HELPDESK SBGUIDANCE

RAVEN

MAIN MENU

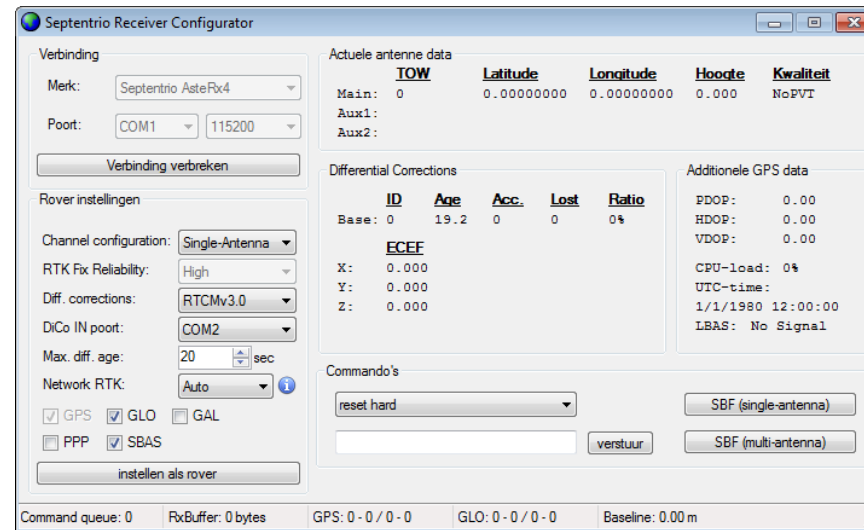
SET UP GPS RECEIVER

1. When you are sure the antenna and antenna cable are in order, the GPS receiver can be reset.

Open the Configurator and GO to Interfaces → GPS → Septentrio Receivers.
Select the right receiver, port and baudrate. Press on Connect.

Choose at Channel configuration Single or Multi.

Choose the right type of Diff. corrections, RTCMv3.0 or CMR

Press on Setup as Rover

Wait till Command queue is on 0.

Press on SBF (single-antenna) for one antenna

Press on SBG (multi-antenna) for two antenna's

Setup for Septentrio AsteRx4 Viper 4(+) →

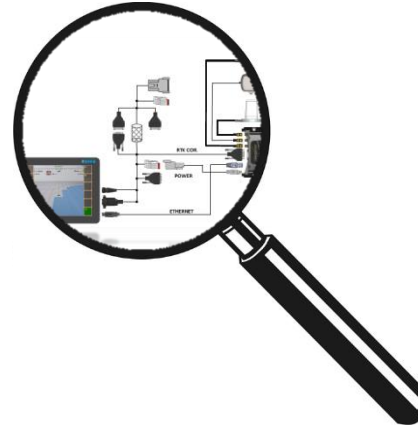
1. Press on the magnifier to take a closer look on the cabling.

2. Some notes:

- Antenna's connected? 2x Laird 1x patch antenna
- Power cable connected?
- Ethernet cable connected?

- Viper 4 adapter harness, Dico In connected to SlingShot modem?
- Viper 4, RTK-COR connected to SlingShot modem?

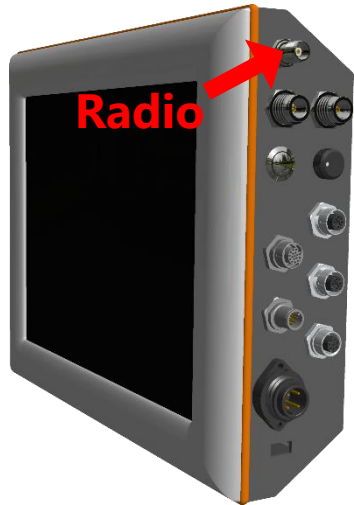
GeoStar 200 / 250

1. Check if the radioantenna cable is connected with the radioantenna. Choose the right type of terminal and look where the radioantenna cable needs to be connected.

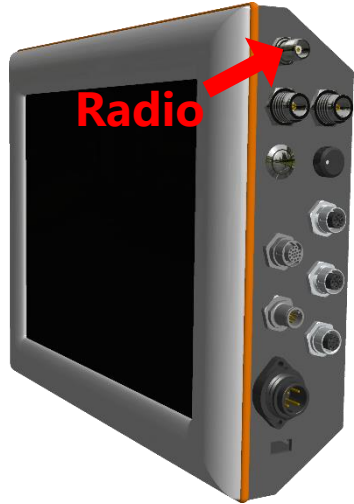
GeoStar 200 / 250

1. Check if the radioantenna cable is connected with the radioantenna. Choose the right type of terminal and look where the radioantenna cable needs to be connected.

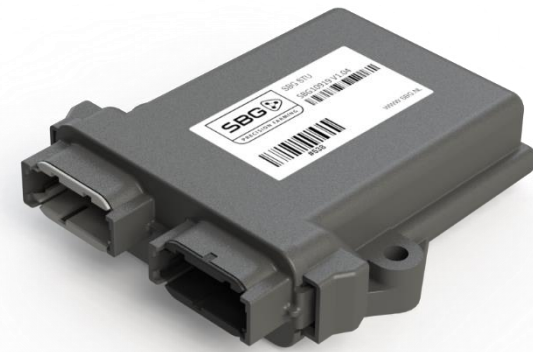
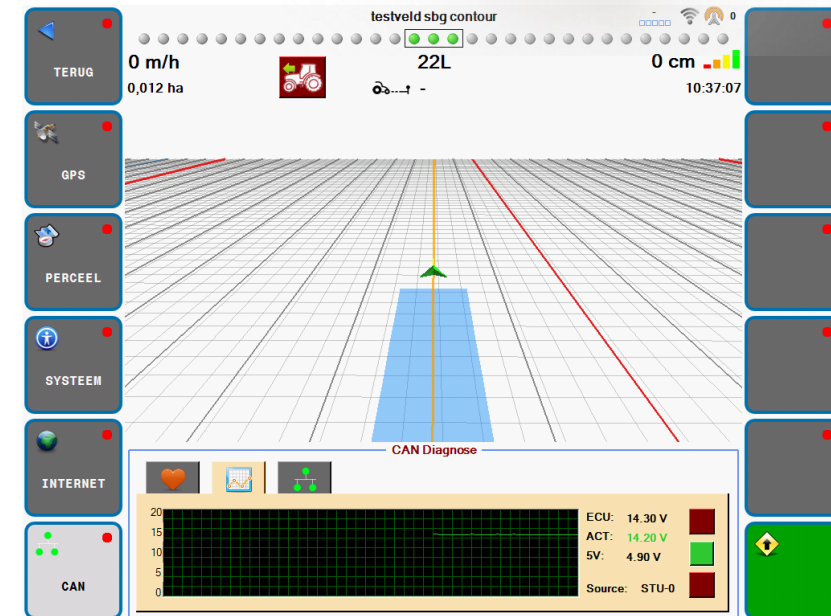
ERROR MESSAGES

1. Check at Info > CAN > second tab if ACT Power is around 14V. If ACT is 0 check relays, fuses and cabling.
2. ACT is around 14V try another STU.
3. Replacing the STU by another one can indicate that the STU is broken.

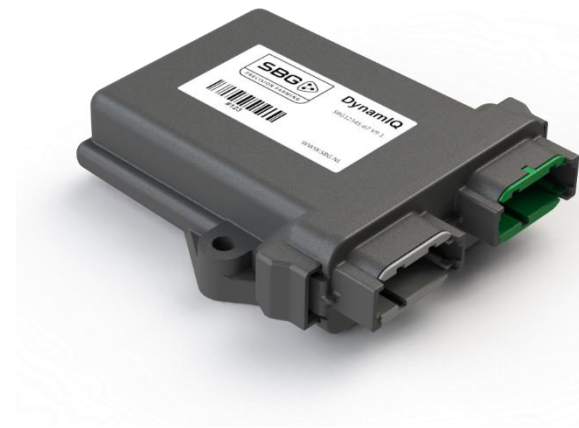
ERROR MESSAGES

No communication with DynamiQ.

1. Check relays, fuses and cabling.
2. Check the CAN connector at the terminal.
3. Switch off the terminal and measure the CAN resistance on the green and yellow wires at the DynamiQ and STU (grey Deutsch connector)
 - Implement Ready without implement 120 Ohm
 - Implement Ready with implement 60 Ohm
 - Basic Harness 60 Ohm
4. Replacing the DynamiQ by another one can indicate that the DynamiQ is broken.

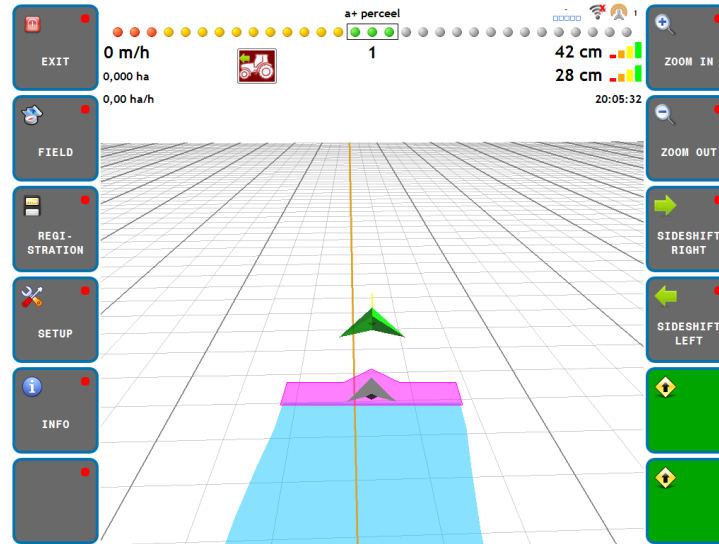
STEERING

1. If there is a problem with steering in combination with SBGuidance follow the next steps to find out what the problem is. First choose where the problem is, tractor steering or implement steering.

Make sure all the offsets are correct! You can find the offsets at Settings > Offsets.

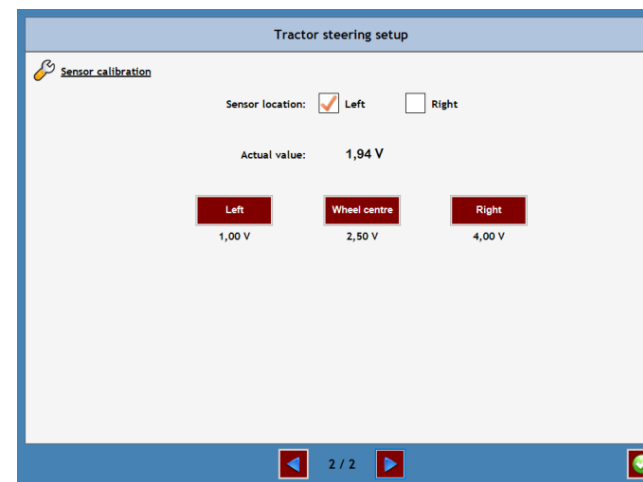
WHEEL ANGLE SENSOR PROBLEM

In some cases the tractor can be swinging around the guidance line because of a problem with the wheel angle sensor. Figure out if the wheel angle sensor is working correctly:

1. Go to Settings > Vehicle and press on the gearwheels button at the right bottom side. Go to page 2
2. Now you see the actual value and the saved values of the sensor for left, centre and right.
3. Turn the steering wheel completely to the left and check if there is a voltage behind actual voltage. It should be something around 1-1,5 V
4. Now turn the steering wheel slowly to the right, and check if the actual value rises. There must be no gaps! (0 V) When the steering wheel is completely to the right the actual value will be around 4-4,5 V. The mentioned values for left and right can also be opposite.

If there are gaps (0 V) there is something wrong with the wheel angle sensor or the cable. Check the cable and sensor visually. You can disconnect the disk of the sensor and clean it. Replacing the sensor and/or cable can also declare the problem.
